**Severely deteriorated culvert
structurally rehabilitated
with the CIPP
Poly-Triplex® Liner System.**

Brighton, CO

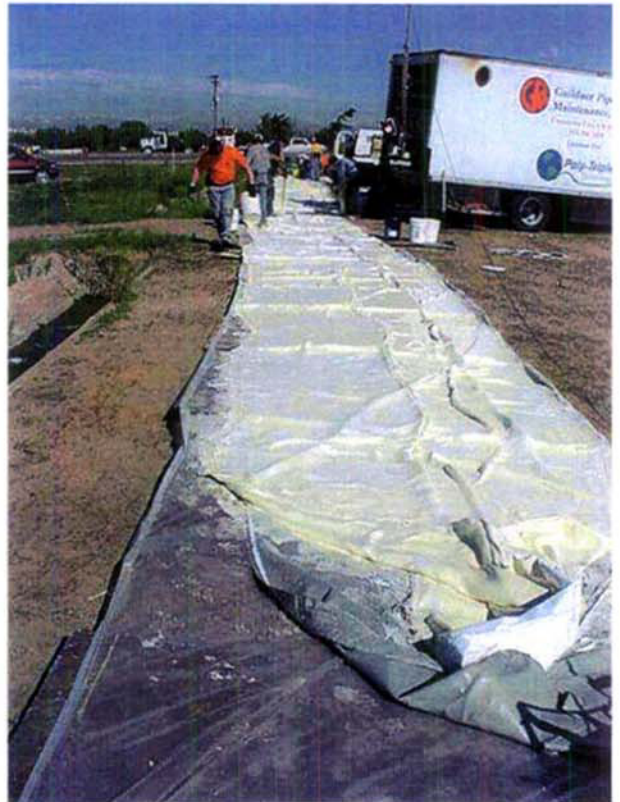
Epoxy Resin applied to Liner prior to installation.

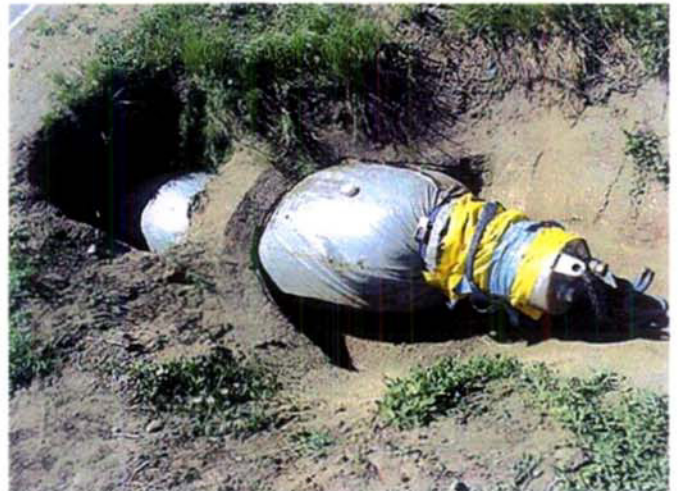
Poly-Triplex® Liner Curing (approx. 3 hours).

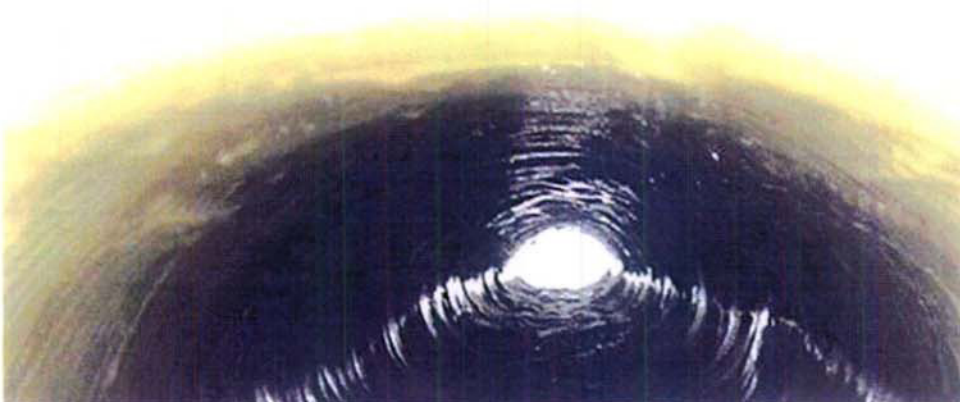
Corrugated Culvert Pipe
110 feet long under
4-lane divided highway
completely rehabilitated
in one day with the
Poly-Triplex Liner System
with no traffic disruption.
