# Florida D.O.T. Destin, Florida

Rehabilitation of  
30" x 72' Corrugated Culvert Pipe  
with the  
Poly-Triplex Liner System.

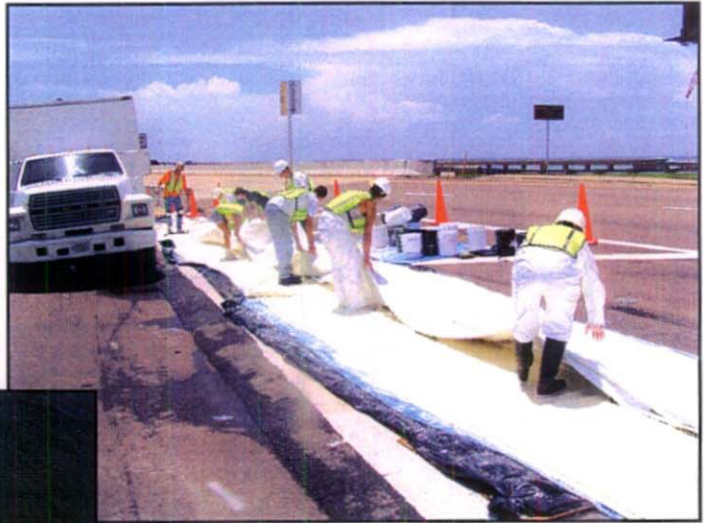
Poly-Triplex Liner System is saturated with epoxy resins and prepared to be inserted into the deteriorated culvert.

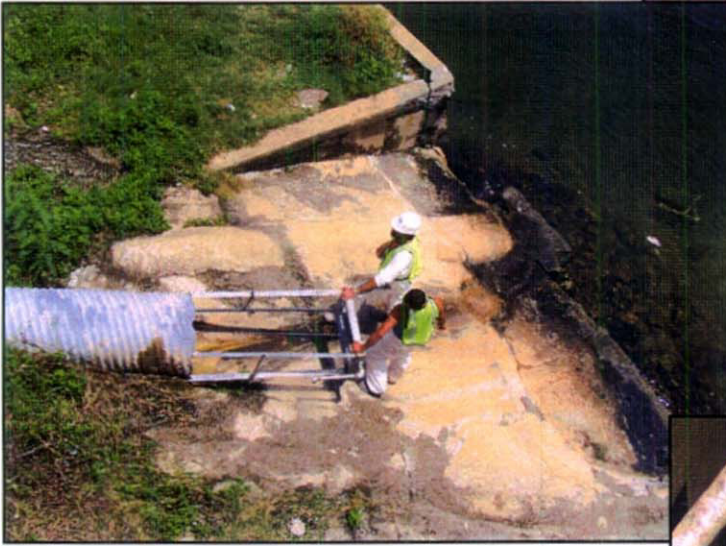
Liner is winched through the culvert then cured in place with air pressure and steam heat injection.

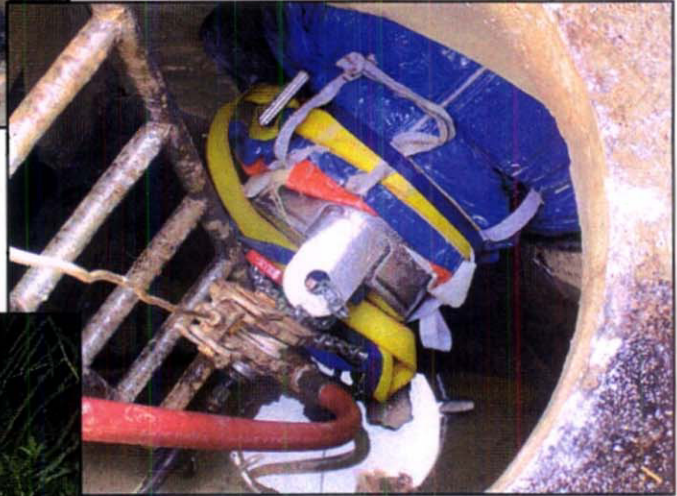
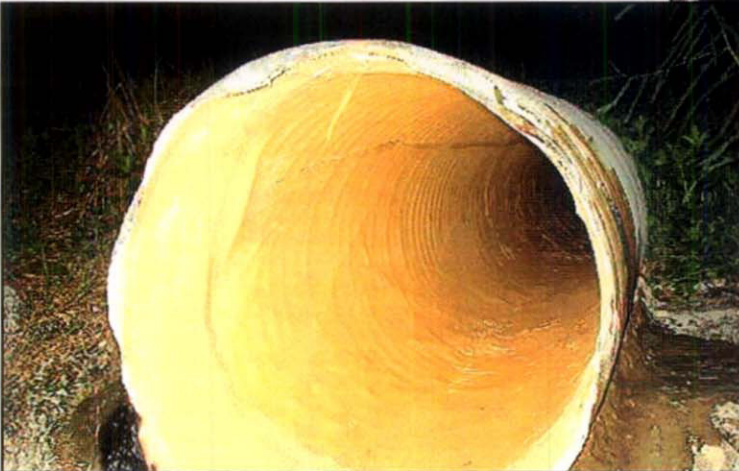
**Deteriorated Culvert is Structurally Rehabilitated  
in one day with the Patented CIPP  
Poly-Triplex® Liner System.**
